PUGET SOUND VITAL SIGNS

INDICATOR FEEDER BLUFFS IN FUNCTIONAL CONDITION

Feeder bluffs in functional condition

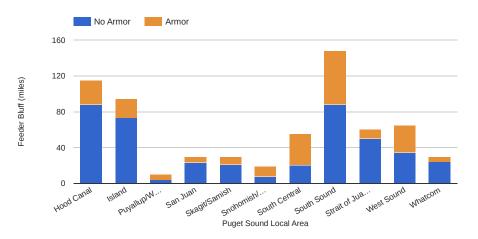
By: Shoreline Length

Extent of feeder bluff shorelines where armor is present (orange) or not present (blue) by Puget Sound Local Area. The 11 Local Area geographies are derived from the Puget Sound Partnership Action Areas to represent local communities working to advance the Partnership's Action Agenda.

- Feeder bluffs stretch along 656 miles (27%) of Puget Sound's total 2,460 marine shoreline miles. 34% (224 miles) of the feeder bluff shoreline is armored.

- Feeder bluffs are present throughout the Puget Sound region; however, their relative length and the extent
 of armor varies by Local Area. We see higher rates of armor on feeder bluffs in the more developed parts of
 Puget Sound, including the Puyallup/White, South Central, and Snohomish/Stillaguamish Local Areas. See
 the indicator's Interpretation of Results for details.
